# New Hampshire Volunteer Lake Assessment Program

## 2003 Biennial Report for Stone Pond Marlboro

NHDES Water Division Watershed Management Bureau 29 Hazen Drive Concord, NH 03301

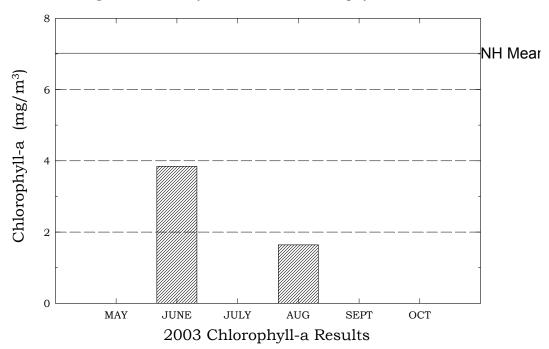
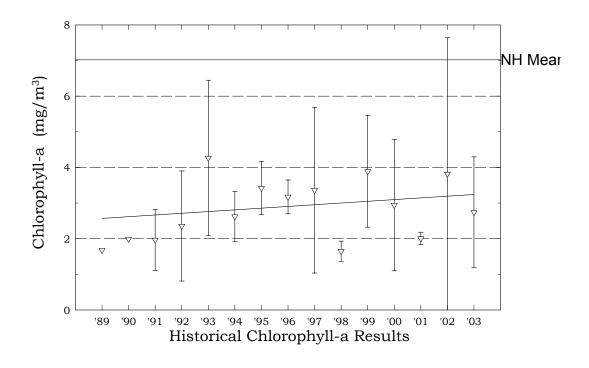
Figure 1. Monthly and Historical Chlorophyll-a Results

Figure 1 and Table 1: The graphs in Figure 1 (Appendix A) show the historical and current year chlorophyll-a concentration in the water column. Table 1 (Appendix B) lists the maximum, minimum, and mean concentration for each sampling season that the lake/pond has been monitored through the program.

The current year data (the top graph) show that the chlorophyll-a concentration *decreased* from June to August. The chlorophyll-a concentration on both sampling events was *much less than* the state mean.

Overall, the statistical analysis of the historical data (the bottom graph) shows that the mean annual chlorophyll-a concentration has **not significantly changed** monitoring began in **1989**. Specifically, the chlorophyll-a concentration has fluctuated, but has *not continually increased or continually decreased* during this period. (Note: Please refer to Appendix E for the detailed statistical analysis explanation and data print out.)

While algae are naturally present in all lakes/ponds, an excessive or increasing amount of any type is not welcomed. In freshwater lakes/ponds, phosphorus is the nutrient that algae depend upon for

growth. Algal concentrations may increase with an increase in nonpoint sources of phosphorus loading from the watershed, or inlake sources of phosphorus loading (such as phosphorus releases from the sediments). Therefore, it is extremely important for volunteer monitors to continually educate residents about how activities within the watershed can affect phosphorus loading and lake/pond quality.

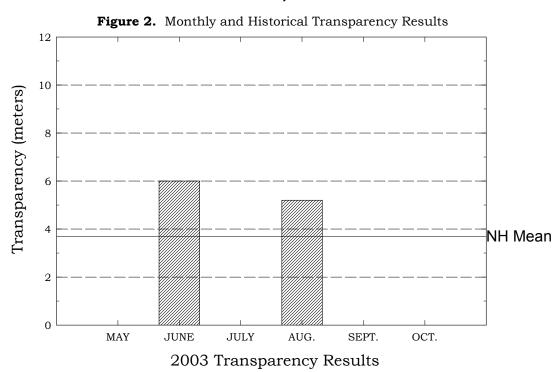
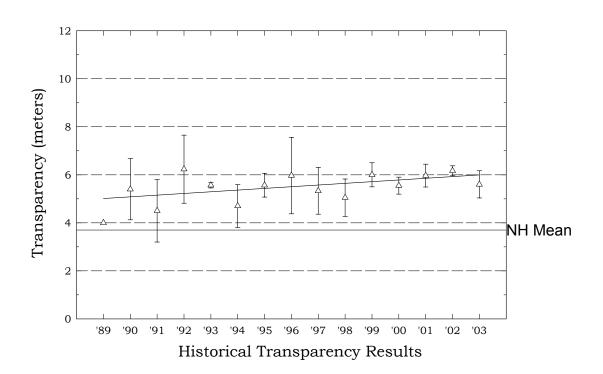
Figure 2 and Table 3: The graphs in Figure 2 (Appendix A) show historical and current year data for lake/pond transparency. Table 3 (Appendix B) lists the maximum, minimum and mean transparency data for each sampling season that the lake/pond has been monitored through the program.

The current year data (the top graph) show that the in-lake transparency **decreased slightly** from June to August. The transparency on both sampling events was **greater than** the state mean.

Overall, the statistical analysis of the historical data show that the mean annual in-lake transparency has **significantly increased** since monitoring began. Specifically, the transparency has **improved** on average by **approximately 1.5 percent** per sampling season during the sampling period **1989** to **2003**. (Note: Please refer to Appendix E for the statistical analysis explanation and data print out.) We hope this trend continues!

Typically, high intensity rainfall causes erosion of sediments into lakes/ponds and streams, thus decreasing clarity. Efforts should continually be made to stabilize stream banks, lake/pond shorelines, disturbed soils within the watershed, and especially dirt roads located immediately adjacent to the edge of tributaries and the lake/pond. Guides to Best Management Practices designed to reduce, and possibly even eliminate, nonpoint source pollutants, such as sediment loading, are available from DES upon request.

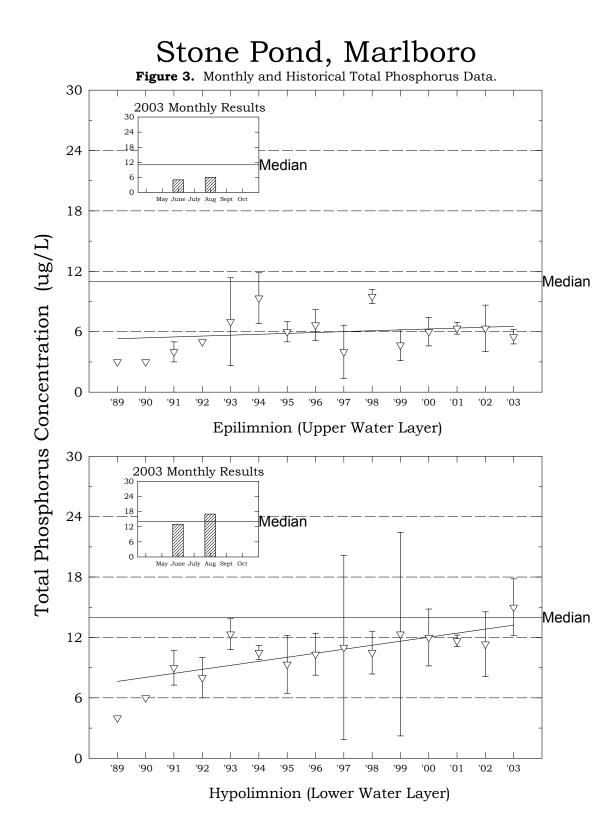
Figure 3 and Table 8: The graphs in Figure 3 (Appendix A) show the amounts of phosphorus in the epilimnion (the upper layer) and the hypolimnion (the lower layer); the inset graphs show current year data. Table 8 (Appendix B) lists the annual maximum, minimum, and median concentration for each deep spot layer and each tributary since the lake/pond has joined the program.

The current year data for the epilimnion (the top inset graph) and the hypolimnion show that the phosphorus concentration **increased slightly** from June to August.

The epilimnetic phosphorus concentration in June and August was **much less than** the state median.

The hypolimnetic phosphorus concentration in June was **slightly less than** the state median and in August was **greater than** the state median.

Overall, the statistical analysis of the historical data show that the phosphorus concentration in the epilimnion (upper layer) has **not significantly changed** since monitoring began in **1989**. Specifically, the phosphorus concentration in the epilimnion has **fluctuated**, but has not continually increased or continually decreased since monitoring began. In addition, the annual mean has been **less than** the state median since monitoring began. (Note: Please refer to Appendix E for the statistical analysis explanation and data print out.)

Overall, the statistical analysis of the historical data show that the phosphorus concentration in the hypolimnion (lower layer) has **significantly increased** since monitoring began. Specifically, the phosphorus concentration in the hypolimnion has **worsened** on average at a rate of approximately **5 percent** per season during the sampling period **1989** to **2003** (Please refer to Appendix E for the statistical analysis explanation and data print out).

One of the most important approaches to reducing phosphorus loading to a waterbody is to continually educate watershed residents about its sources and how excessive amounts can adversely impact the ecology and value of lakes and ponds. Phosphorus sources within a lake or pond's watershed typically include septic systems, animal waste, lawn fertilizer, road and construction erosion, and natural wetlands.
